EUROPEAN PATENT APPLICATION

(71) Applicant: UNITED TECHNOLOGIES
CORPORATION
Hartford, CT 06101 (US)

(54) Method for repairing an apertured gas turbine component

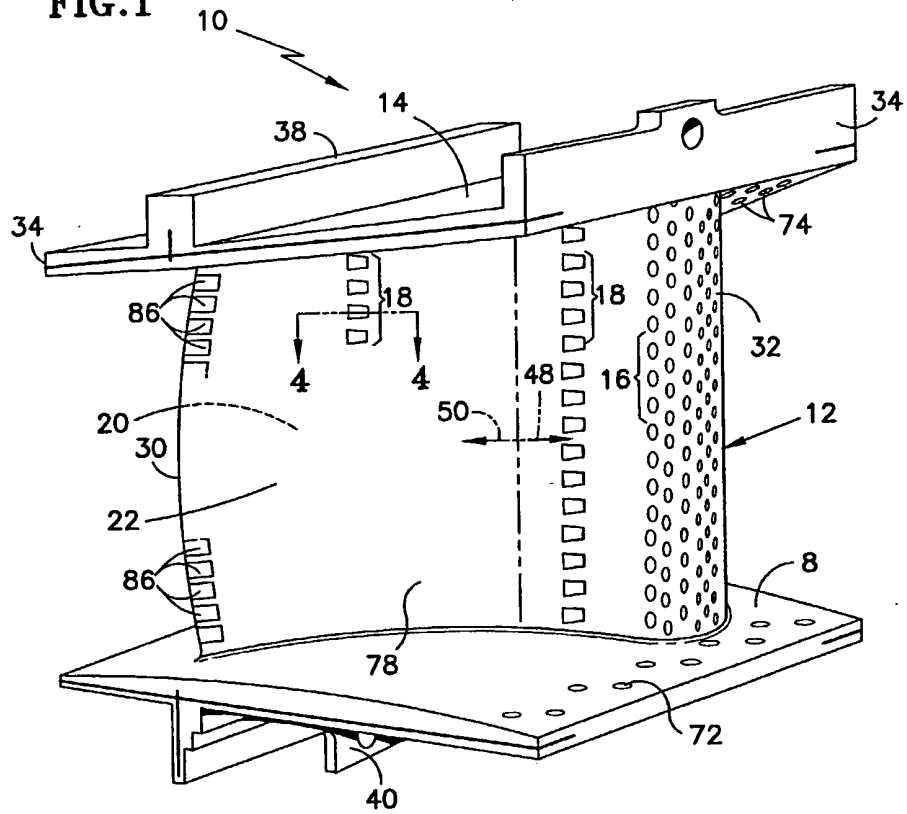
FIG.1

Fig. 1 is a perspective view of a typical gas turbine engine high pressure turbine vane;

[0025] Referring to Fig. 1, a high pressure turbine vane (article) 10 is shown. Referring also to Figs. 2 and 3, a top view and a bottom view are respectively shown for the vane 10 of Fig. 1. The vane 10 comprises an airfoil section (airfoil) 12 having at least one internal cavity 24 (Fig. 2), the internal cavity 24 having an internal surface 26 (Fig. 2). The airfoil section 12 has a convex surface 20 and a concave surface 22. The convex and concave surfaces 20, 22, respectively, are bounded by a trailing edge 30 and a leading edge 32 and together form an exterior surface 78 of the airfoil. The exterior surface 78 is exposed to the hot gas path. The trailing edge 30 of the airfoil 12 includes cooling slots 86. Also, the airfoil section 12 is bounded by an inner diameter platform (platform) 8 and an outer diameter platform (platform) 14. The inner and outer diameter platforms 8, 14 create the gas path annulus and include cooling holes 72, 74, respectively. The outer diameter platform 14 includes opposing flanges 34, at least one cover 36 (Fig. 2), preferably two, and a rail 38. The inner diameter platform 8 includes a rail 40 and a cover 42 (Fig. 3), preferably two.

[0027] The vane 10 lies in the hot gas path and the vane 10 is air-cooled by flowing cooling air, typically from the compressor discharge, into the internal cavities 24. Cooling air enters the internal cavities 24 through corresponding openings in the platforms 8, 14. This air cools the internal surface 26 of the airfoil 12 by convection or internal baffle impingement and cools the convex and concave surfaces 20, 22, respectively, of the airfoil 12 by film cooling. The air is directed from the internal cavities 24 and outward across the vane 10 by a plurality of cooling holes, preferably cylindrical cooling holes 16 and diffusion cooling holes (diffusion holes) 18, to help it withstand the high temperatures to which it is exposed. The cooling air is also directed across the platforms 8, 14 upon exiting the respective cooling holes 72, 74. The trailing edge 30 is cooled by air exiting through the slots 86.

[0028] Although Fig. 1 shows the plurality of cooling holes 16, 18 located on the concave surface 22, it is readily understood by those skilled in the art that the plurality of cooling holes 16, 18 are formed on both the convex and concave surfaces 20, 22, respectively.

[0030] To further protect the vane 10 (Fig. 1) from high temperatures, the airfoil 12 and the platforms 8, 14 are coated with a protective surface coating, preferably a thermal barrier coating (TBC) system. The thermal barrier coating system 44 comprises a metallic bond coat 46 disposed over a substrate 58 of the vane 10 (Fig. 1), and a ceramic top coat 75 on top of the bond coat 46.

[0031] Referring now to Figs. 1 and 4, it is noted that the vane 10 has a plurality of diffusion holes 18 which may have various geometries and predetermined air flow characteristics based on location within the vane 10. The representative diffusion hole 18, shown in Fig. 4, has a metering passage 60 in fluid communication with a diffusion passage (mouth) 52, each having a predetermined geometry. The metering passage 60 has an inlet 76 with a predetermined throat area, shown as A_t , where the throat area A_t provides a predetermined air flow requirement. Thus, the inlet 76 regulates cooling air flow into the diffusion holes 18 from the internal cavities 24. The diffusion passage 52 is axially diverging, nonregulatory and extends from the inlet 76 to an outlet 77 at the exterior surface 78 of the vane 10. The diffusion passage 52 facilitates the film cooling of the exterior surface 78 of the airfoil 12 as the cooling air exits from the diffusion passage 52 of the diffusion hole 18. The diffusion passage 52 also includes an inner shaped portion (inner diffuser portion) 80 while the metering passage 60 includes an inner metering portion 82.

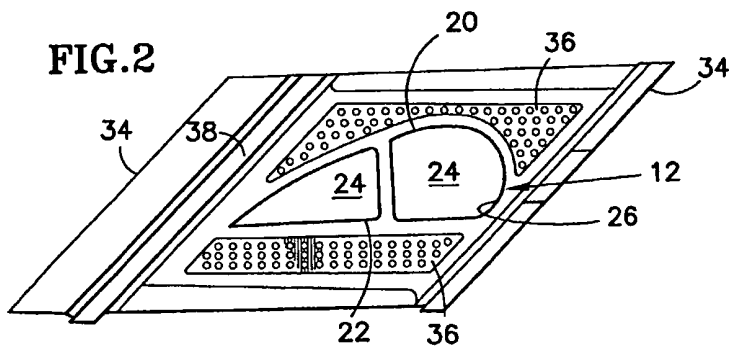
FIG.2

Fig. 2 is a top view of the vane of Fig. 1;

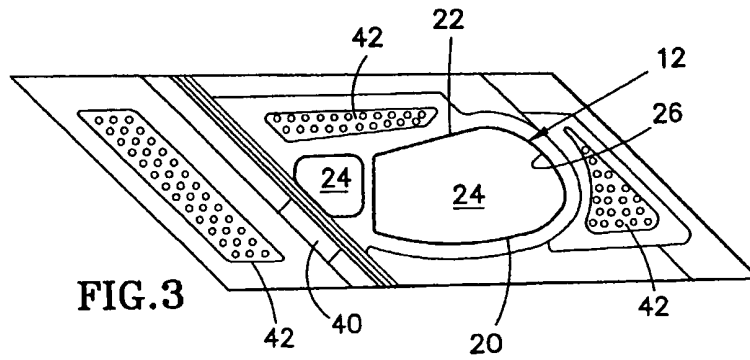
FIG.3

Fig. 3 is a bottom view of the vane of Fig. 1;

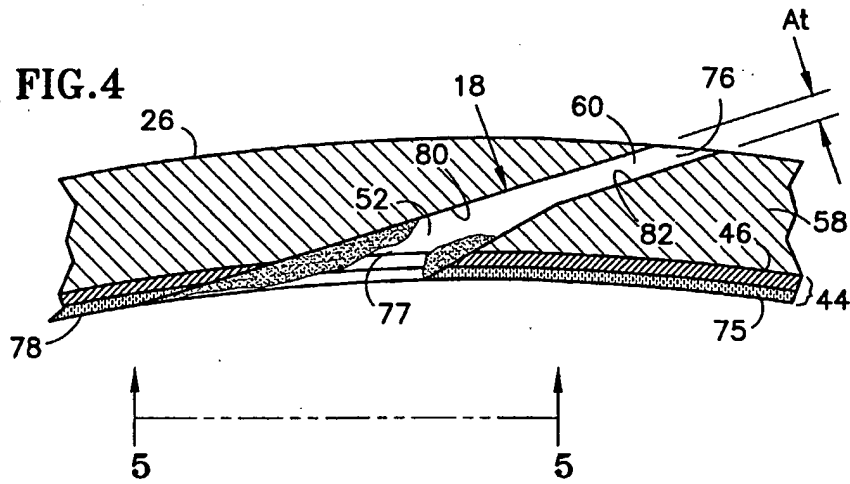
FIG.4

Fig. 4 is an enlarged cross-sectional view taken essentially in the direction 4-4 of Fig. 1 and illustrating the vane substrate, an existing protective coating applied to the substrate and a typical diffusion cooling hole extending through the substrate and the coating;

[0029] Referring to Fig. 4, a cross-sectional view of the wall thickness of the airfoil 12, and in particular the diffusion hole 18, is shown taken along the line 4-4 of

[0048] Referring now to Figs. 1, 4 and 5, diffusion holes 18 located in region 50 may require reworking. The application of the nonoriginal metallic bond coat 46 to the entire surface 78 of the vane 10 may result in a quantity of excess bond coating accumulating in the diffusion passage 52 of the diffusion holes 18 thus reducing the area through which the cooling air passes. Since this "coatdown" phenomena, as shown in Figs. 4 and 5, affects most, if not all of the diffusion holes 18 in region 50, the effectiveness of the cooling medium is diminished and the vane's durability is compromised. The coatdown phenomenon is normally not a problem during the manufacture of original equipment vanes since the protective coatings, and in particular, the metallic bond coat, are usually applied prior to installation of the cooling holes.

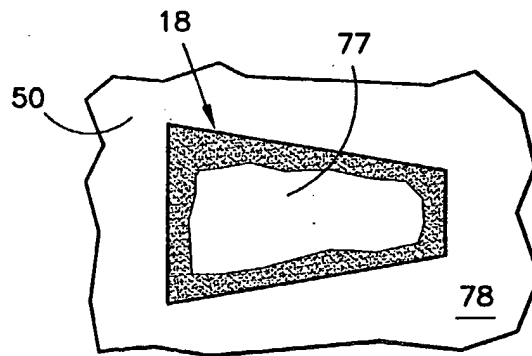
FIG.5

Fig. 5 is a view taken essentially in the direction 5-5 of Fig. 4 showing the diffusion hole prior to the repair of the present invention;

Fig. 1. Fig. 5 shows a view taken essentially in the direction 5-5 of Fig. 4 showing the diffusion hole 18 prior to the repair of the present invention.

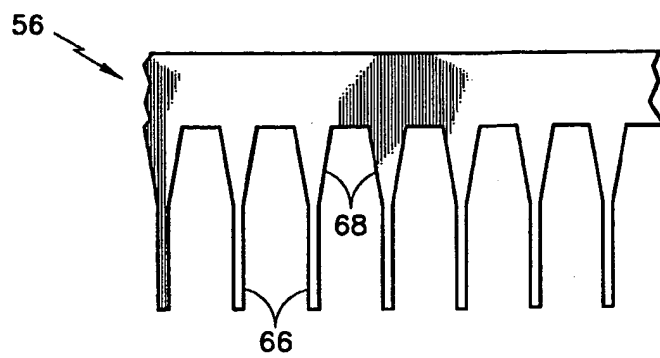
FIG.6

Fig. 6 is a side view of an electrode suitable for use with the repair method of the present invention; and

[0051] Referring to Figs. 6 and 7, electrodes 56, 62 suitable for insertion into an electric discharge machining device are shown. Referring to Figs. 1, 4, 5 and 6, the remanufacture and repair of the diffusion holes 18 in local regions 48, 50 of vane 10 using electrodes 56, 62, respectively, will now be described.

[0052] The electrode 56 includes a metering portion 66 and a diffuser portion 68. The electrode 62 includes a diffuser portion 70. It is noted that the geometry of the individual electrodes 56, 62, specifically the respective portions 66, 68, 70, are preselected to correspond to the required shape of the corresponding diffusion hole 18 to which it is used. In particular, the electrode 56 is chosen to restore the inner diffuser portion 80 and inner me-

[0054] In local region 48, the diffusion hole 18 is now remanufactured using the electrode 56. Since the repair material filled the diffusion hole 18, both the metering portion 66 and diffuser portion 68 of the electrode 56 are required to effect the remanufacture. The diffuser portion 68 of the electrode 56 corresponds in shape to the diffuser passage 52, and more specifically, the inner diffuser portion 80, of the diffusion hole 18. While, the metering portion 66 of the electrode 56 corresponds to the metering passage 60, and more specifically, the inner metering portion 82 of the diffusion hole 18.

[0055] However, in local region 50, the diffusion holes 18 may be partially or fully clogged, as described earlier, and therefore will need to be reworked to restore the cooling effectiveness of the diffusion hole 18 as well as vane durability. This is accomplished by using the electrode 62 to remove the excessive bond coat material. The electrode 62 may be easily formed by removing a metering portion from an electrode that has a diffuser portion corresponding in shape to the diffuser passage 52, and more specifically, the inner diffuser portion 80, of the diffusion hole 18. This can be accomplished by using a cutting means, for example scissors, to remove the metering portion.
